HM_010

Re-assembled safety valves type 06388, 06418 by HEROSE unauthorized person

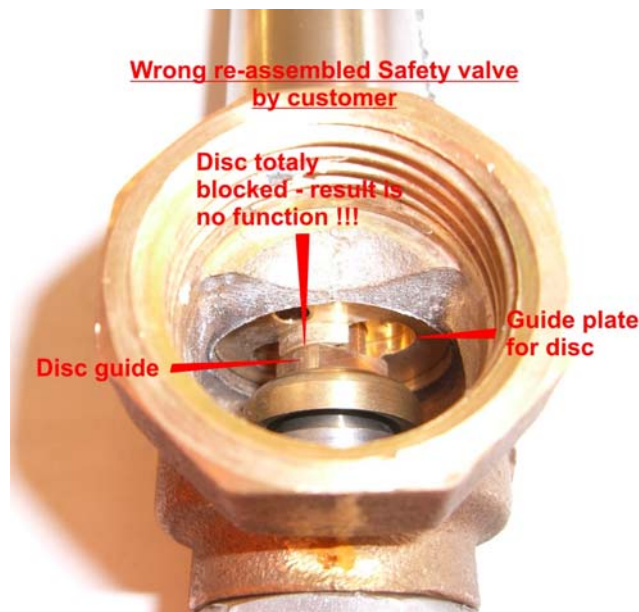
Pict. 1

Beginning of December 2008 and also several times in the past HEROSE was informed by one customer, that the safety valves 06388 and 06418 (with lifting device) does not work in a safety manner. As a reason for this it was found out that other persons than HEROSE authorized personal has disassembled and again re-assembled the safety valves with a wrong and dangerous position of the guide disc and guide plate (see picture 1). If the safety valves will be re-assembled and the disc guide is not fixed in the guide plate the disc will be pressed through the guide plate on the seat and the safety valve is totally blocked!

In all of these cases it has to be pointed out that the original HEROSE-seal was destroyed and HEROSE is out of any guarantee or liability!

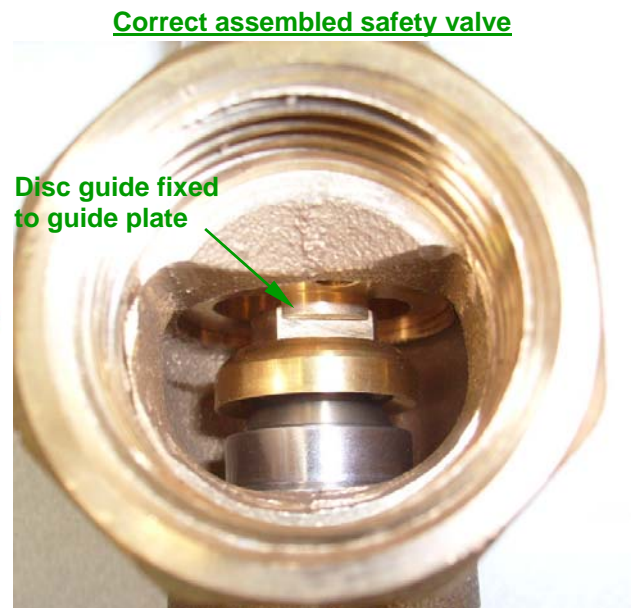
Pict. 2

To be sure that the installed safety valves are re-assembled correctly it can be checked by a visual inspection easily. The correct assembly is shown in picture 2.
